# Manhole Inspection Summary

Manhole # S35II1008MH

Insp Date: **6/13/07 10:22 AM**

**Location** Address: **308 WENDOVER RD**

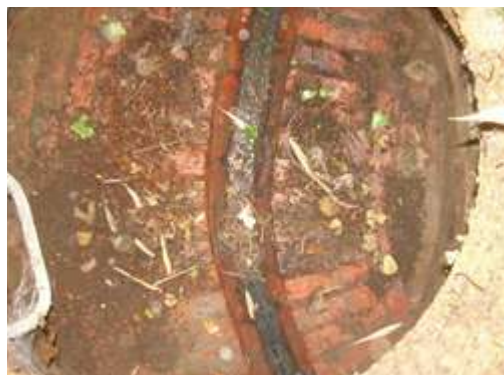
Top View

Bench and Channel debris.

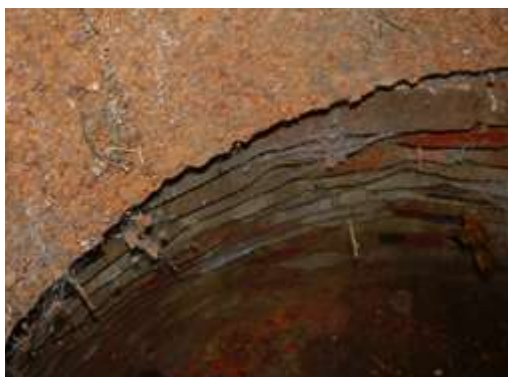
Defect

Corbel and Barrel infiltration.

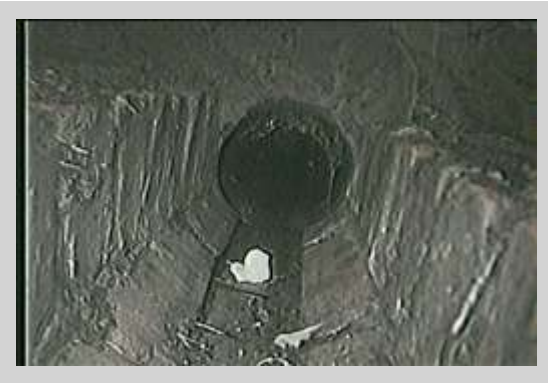
Pipe Out @ 12 O'Clock

Barrel root intrusion and infiltration.

Infiltration: **None** Pipe Seal Cond: **Cracked**

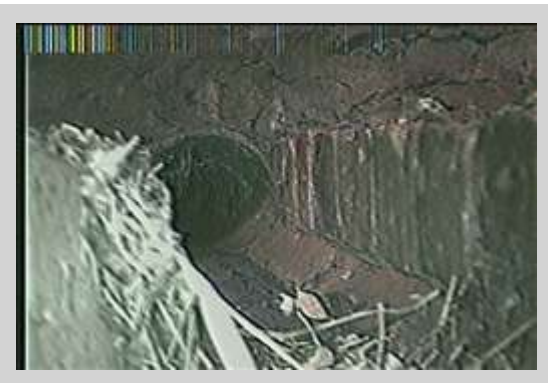
Pipe In @ 4 O'Clock

Barrel deterioration and infiltration. Channel deterioration.

Infiltration: **None** Pipe Seal Cond: **Cracked**
